**ENVIRONMENTAL  
BASELINE SURVEY**

**222<sup>ND</sup> COMBAT COMMUNICATIONS SQUADRON  
CALIFORNIA AIR NATIONAL GUARD**

**COSTA MESA AIR NATIONAL GUARD STATION  
COSTA MESA, CALIFORNIA**

**SEPTEMBER 2002**

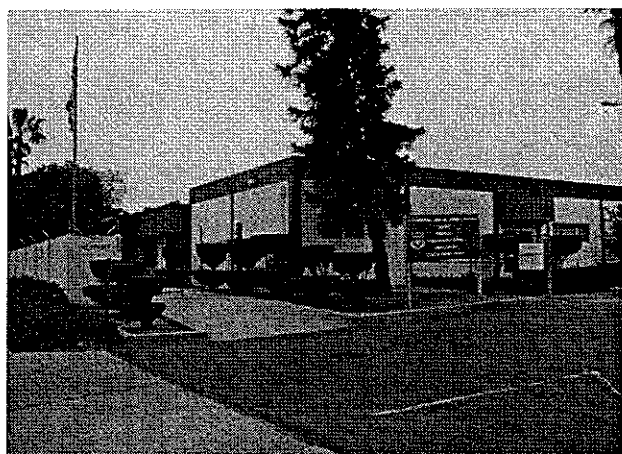
**Photograph 3-1. Front View of Building 1**

**Building 1 – Headquarters**—This building was built in 1964 by the Air Force for administration and electronics maintenance. The building currently is used for the same purpose and contains a dining hall, radio communications rooms, utilities room, classrooms, locker rooms, gym, and administrative offices.

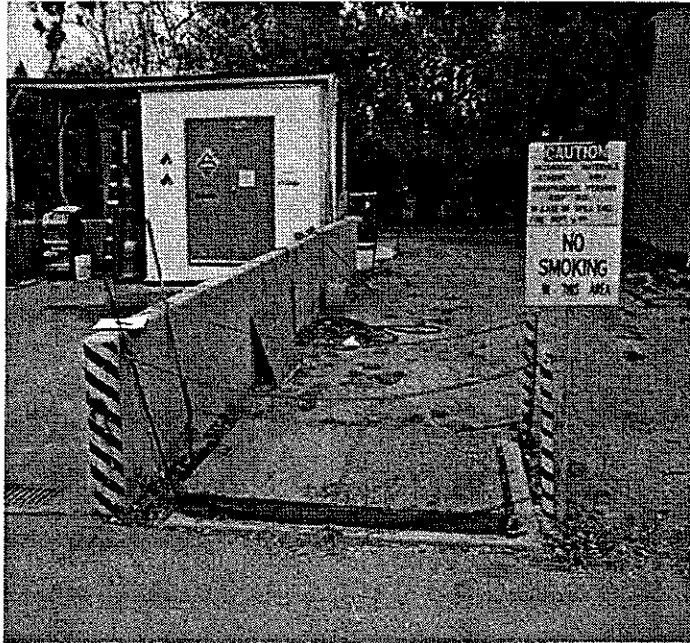
Station personnel noted that automotive maintenance activities were performed within the wash rack and that waste automotive fluids (including battery acid) were discharged to the wash rack drain. The EBS team noted that the concrete in the drain and OWS was in poor shape, possibly due to acid exposure since 1969. Photograph 3-13 shows the interior of the OWS. The wash rack is no longer in use and the OWS is scheduled for removal in 2002.

**Photograph 3-12. Oil/Water Separator Behind Building 2**

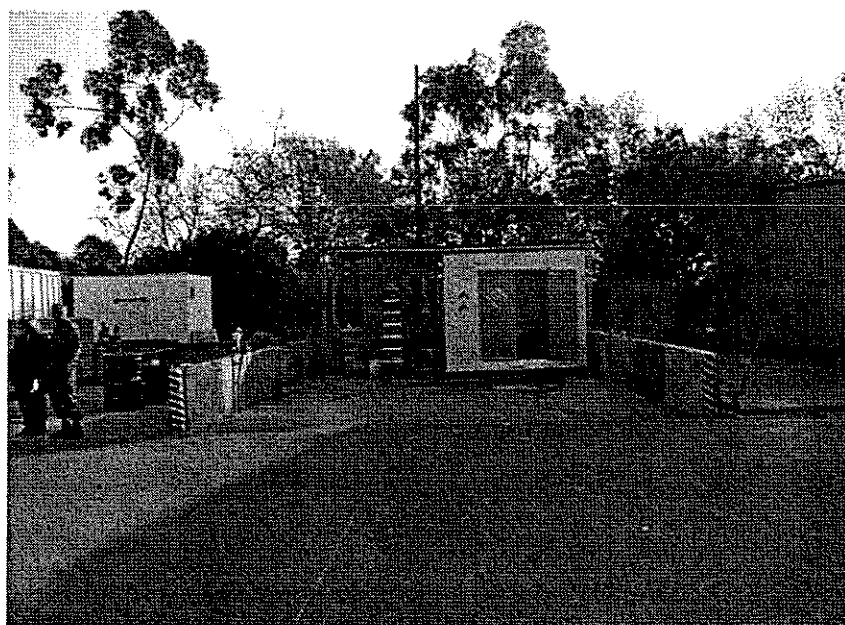
An outdoor vehicle wash rack and OWS were constructed near Building 2 in 1969, as shown in Photograph 3-14. The wash rack is surrounded by 3-foot concrete berms and has a 5-inch asphalt berm at the entrance. Vehicle washwater and stormwater that collects in the wash rack is directed into drains which lead to the adjacent OWS (see Section 3.3.5). The OWS always has discharged to the sanitary sewer.

**Photograph 3-14. Wash Rack at Building 2**

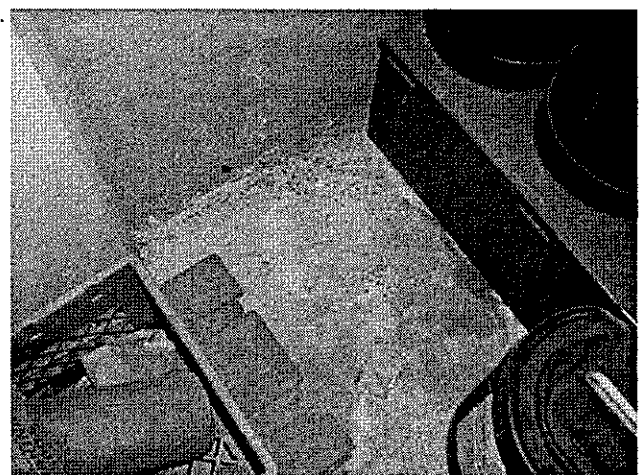
- ***Sulfuric/Battery Acid***—The battery room floor drains at Building 2 (Vehicle Maintenance) received approximately 250 gallons of battery acid from the motor pool and 100 gallons of battery acid from the generator shop each year. The acid was discharged untreated from 1964 to 1975, but was neutralized prior to discharge from 1975 to 1982. Heavy corrosion was noted around the drain prior to its capping in 1990.

**Photograph E-17. Floor of Battery Room in Building #2**

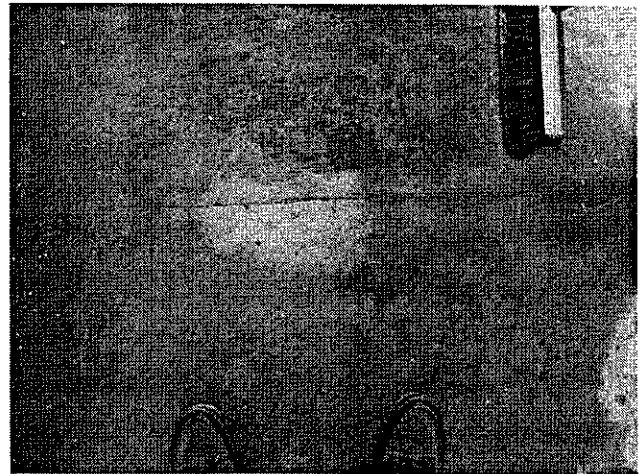
**Photograph E-25. Hydraulic Oil Stain in Concrete Adjacent to Building #2**

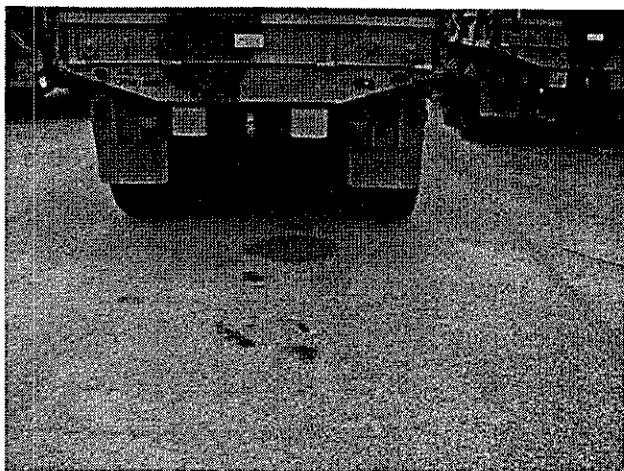
**Photograph E-32. Oil Stain in Parking Lot**
